# Cold Bay Health Clinic

## Alaska Rural Primary Care Facility

### Assessment and Inventory Report

**May 11, 2004**

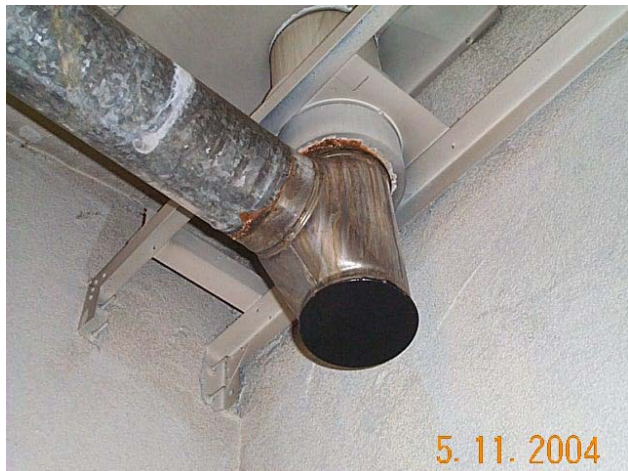
Mco09	02	Severe corrosion on the furnace stack may cause premature failure of this system. The stack cap on the roof is also missing.	Replace the 6"Ø all fuel chimney from the furnace up 15 feet to a new stack cap on the roof. Also provide a new barometric damper at the furnace. Replace the furnace and ductwork per comment M01. The cost for this deficiency is covered by (Mco01).
Mco10	02	There currently is one combustion air openings for the furnace installed and not according to code (IMC section 703).	Provide one additional combustion air opening (6"Ø) ducted from the outside wall. This combustion air opening is to be located 12" from the floor. \$300
Mco11	12	The restroom has been provided with plumbing fixtures that do meet the ADA	Provide ADA and UPC approved barrier free devices at all existing locations.
